**BARN AT BULKINGTON,  
WILTSHIRE**

**PHASE 1 BAT SURVEY**

**HAYES GFS LTD**

**9<sup>th</sup> January 2018**

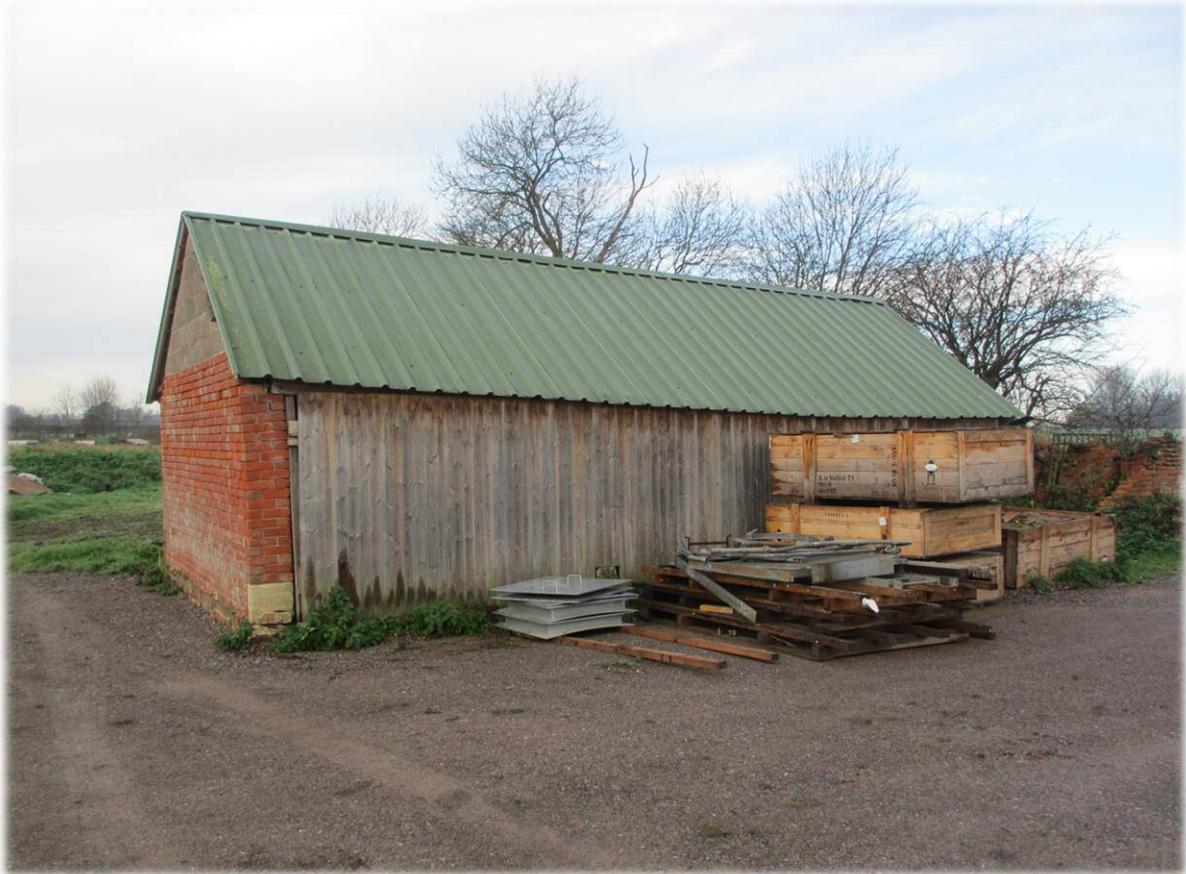
Barn exterior showing east and southern elevations

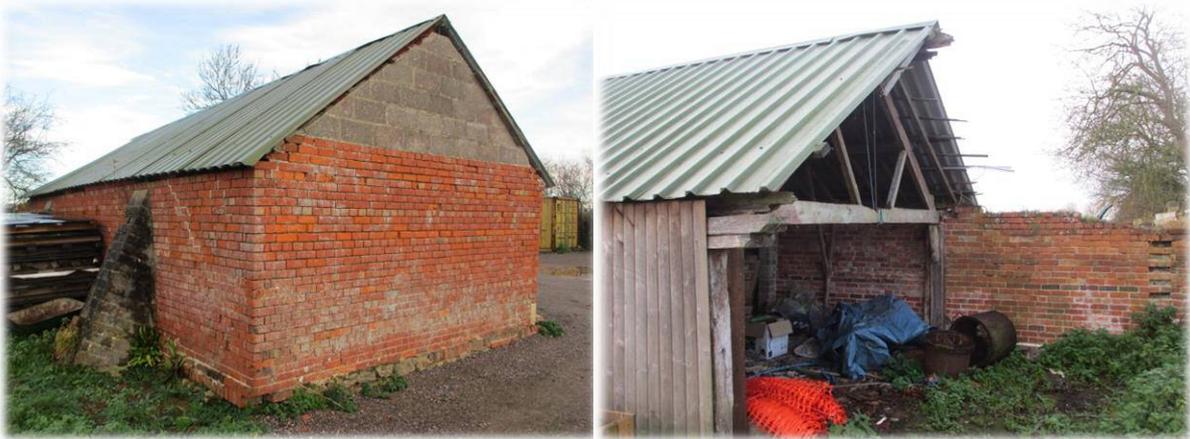
Barn southern gable end (left) and open northern gable end (right)

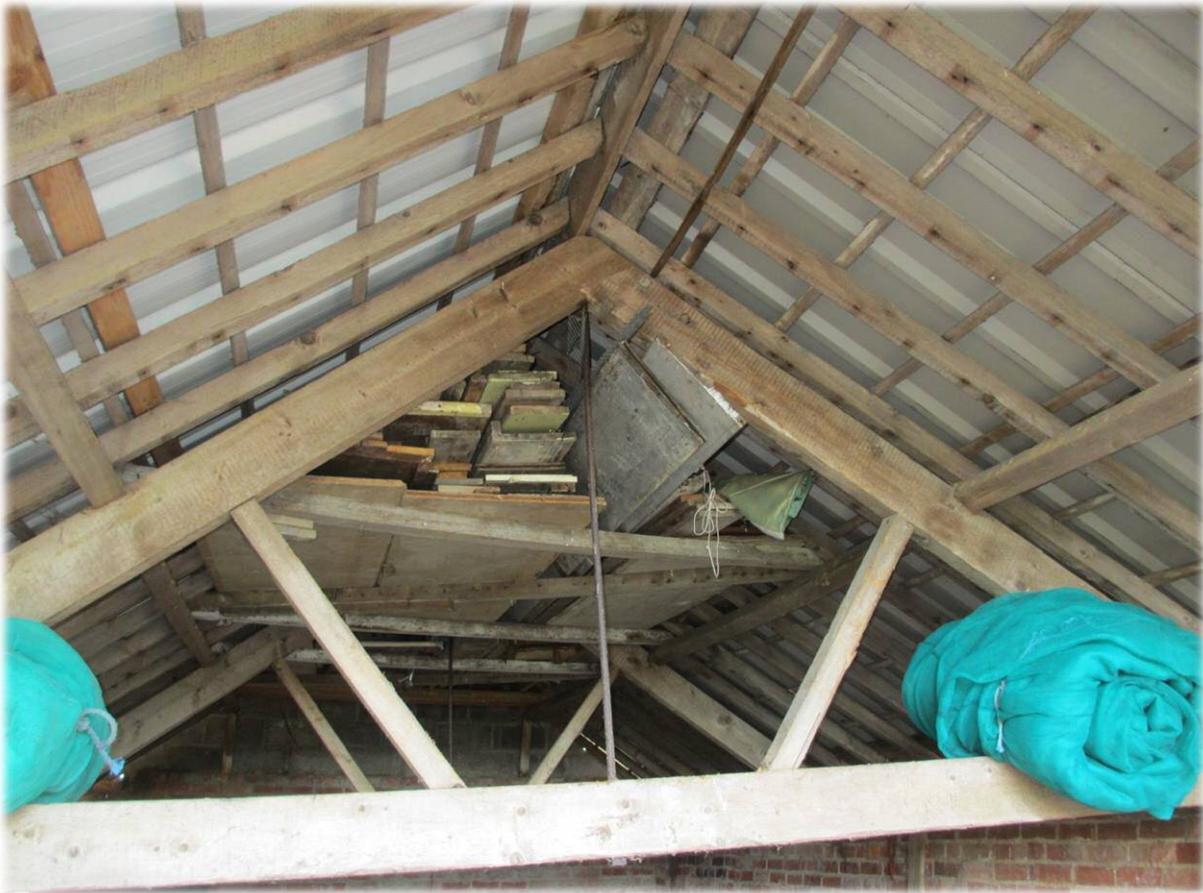
There are no gaps/recesses available for crevice-dwelling bats to exploit associated with the exterior or interior of the barn. There are exposed roof timbers and the ridge board that could provide perches for hanging/clinging bats to potentially exploit, although the interior of the barn is very open, light and draughty making these features largely unsuitable for day roosting bats. However, timber planks have been stacked between the southern-most trusses creating slightly darker conditions at the roof apex.

Internal roof structure of the barn with stacked timber on rafters at southern end

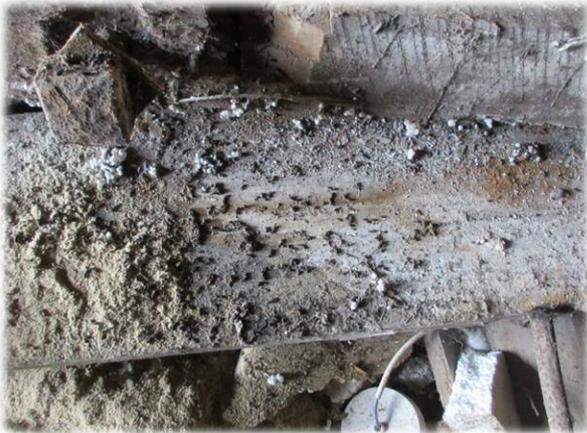
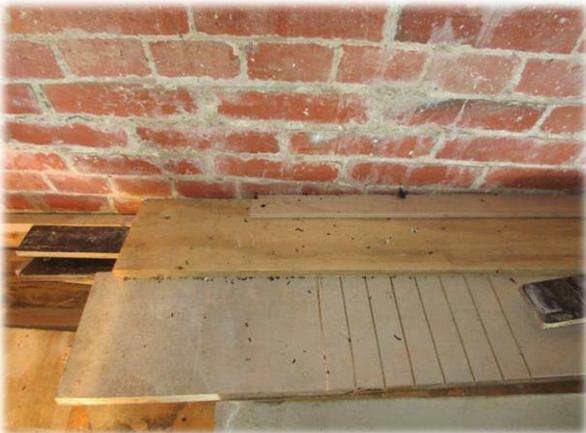
Within the barn two small accumulations of bat droppings were found on the floor within the southern part of the barn, being located under the timber boards stacked across the roof trusses. In total there were approximately 40 droppings of relatively recent origin. Based on visual diagnostics, the droppings are identified as being from lesser horseshoe (*Rhinolophus hipposideros*). However, there were no live bats, no dead bats and no feeding remains. Furthermore, most of the ridge board is webbed.

It is concluded that the barn is a known roost (Category 5) for lesser horseshoe bat. Given the physical structure of the barn, the internal environmental conditions, the number of droppings found, and the lack of other bat signs (i.e. no live bats and no feeding remains) it is considered highly likely that the barn interior is being used as an occasional summer night roost for an individual bat. Based on the findings combined with previous experience/knowledge it is also very likely that the bat is only using the barn towards the end of the season (i.e. early autumn), which is typical behaviour of this species. A preliminary assessment of the roost type and status is provided in Sections 4.1.2 and 4.1.3.

Lesser horseshoe droppings on floor at southern end of the barn

A replacement structure providing suitable night roosting habitat for lesser horseshoe bats should be provided on-site as part of the new development.

This could be a simple timber structure (e.g. shed, lean-to etc.) that has a large flyway (one end open) and exposed roof timbers. The structure should be constructed with a timber frame of a minimum 2m wide and 3m long. The structure could have a pitched or mono-pitched roof, which is at least 1m high at the apex or top of the roof slope.

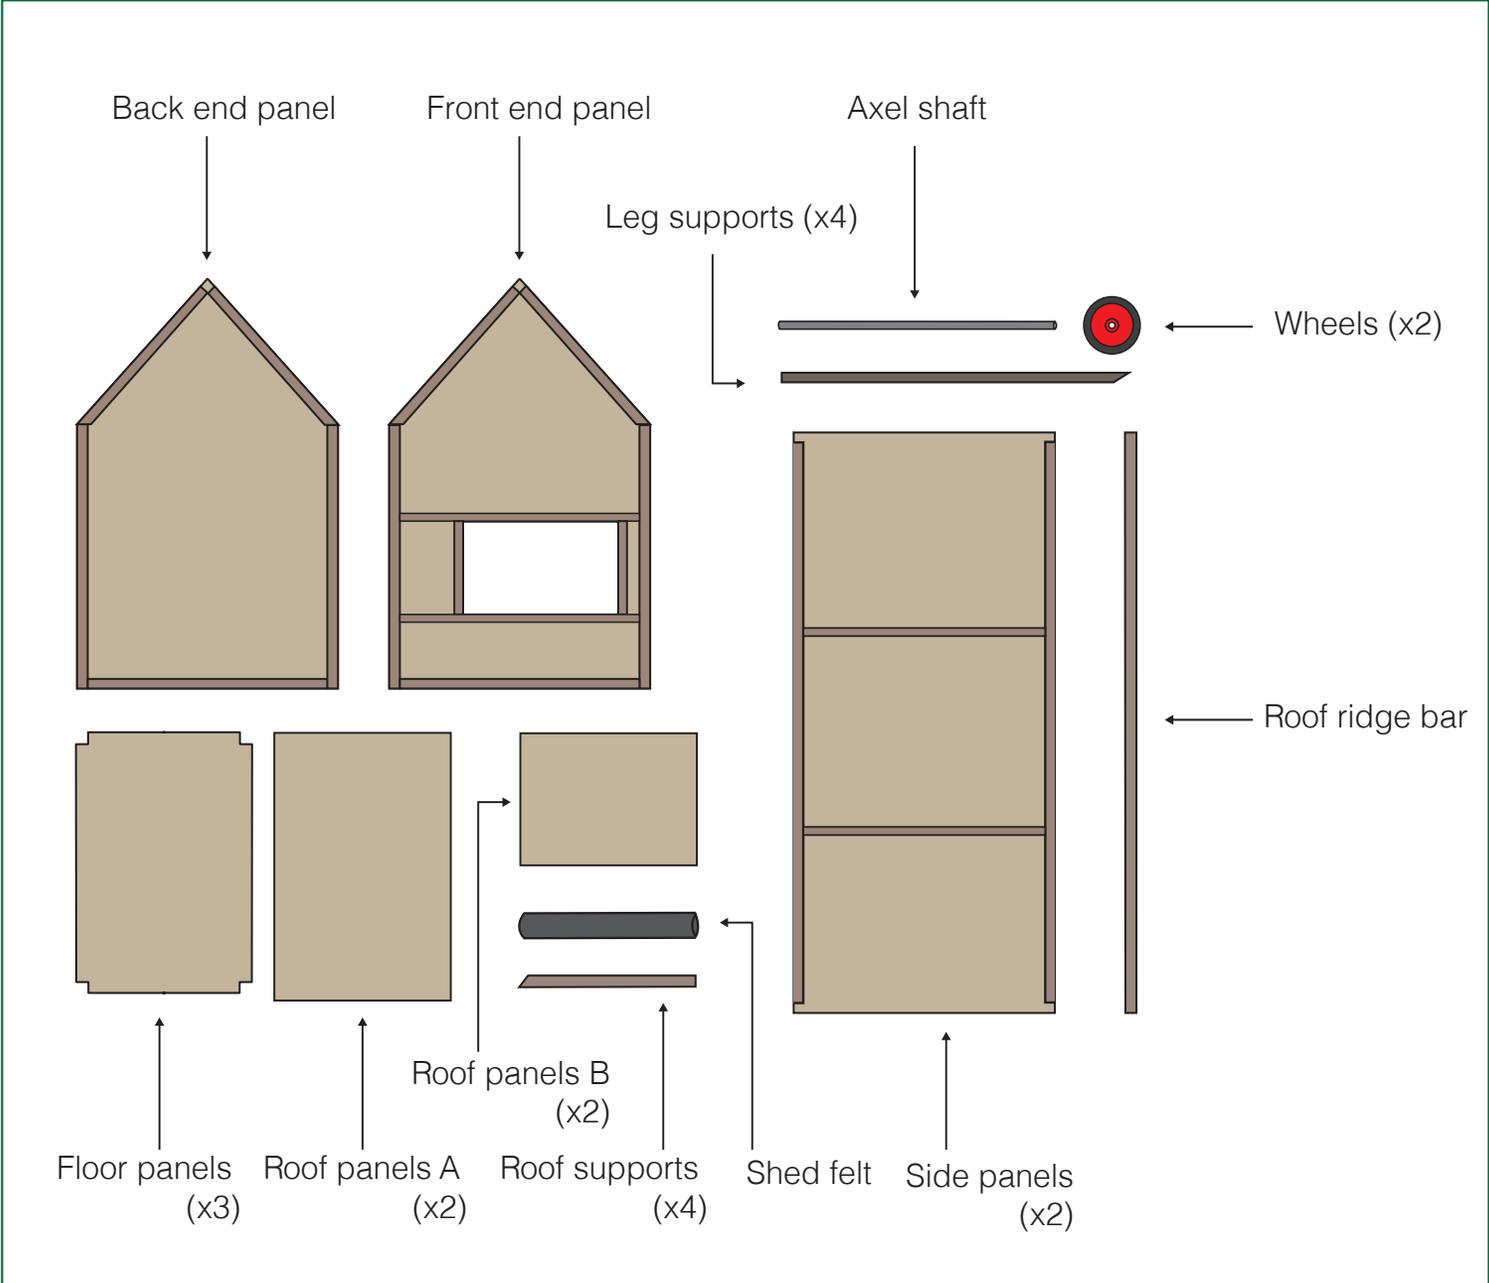
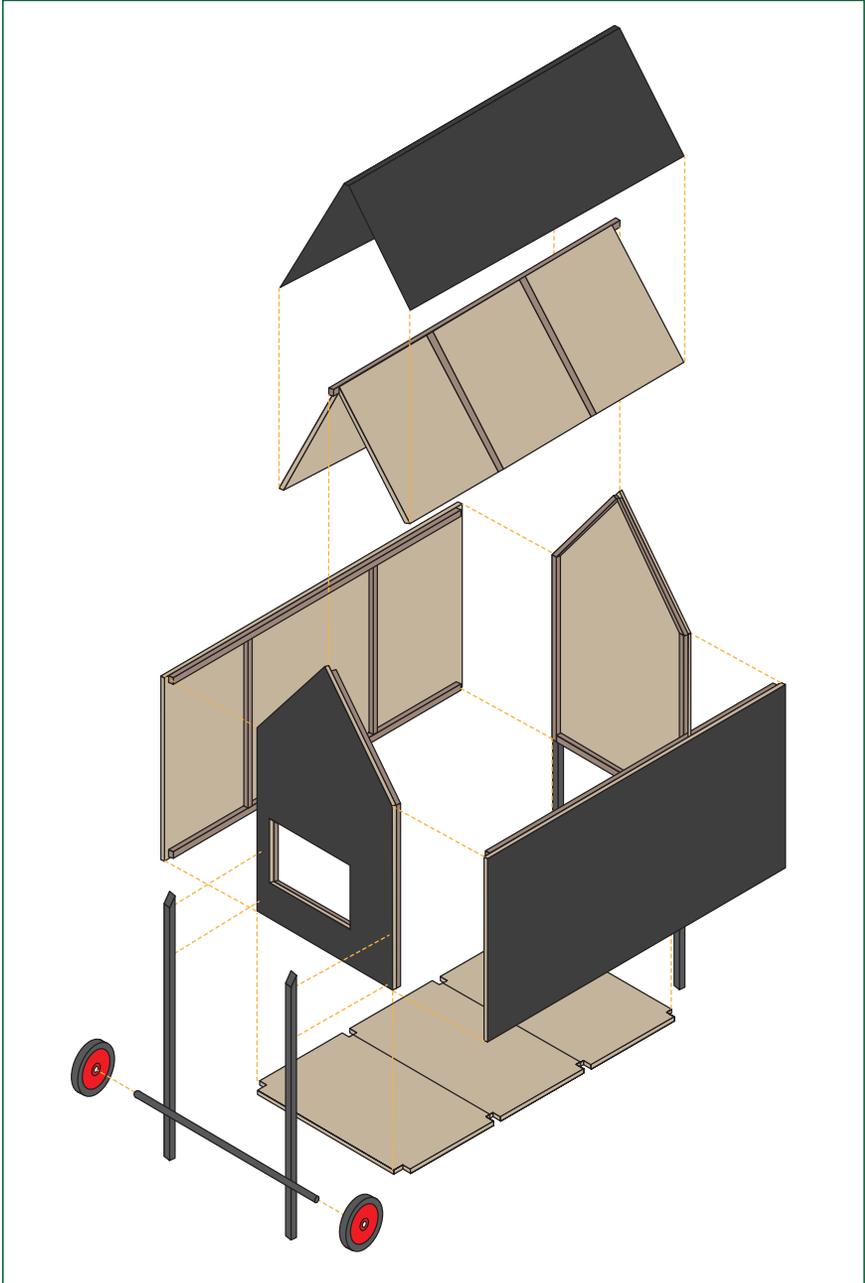
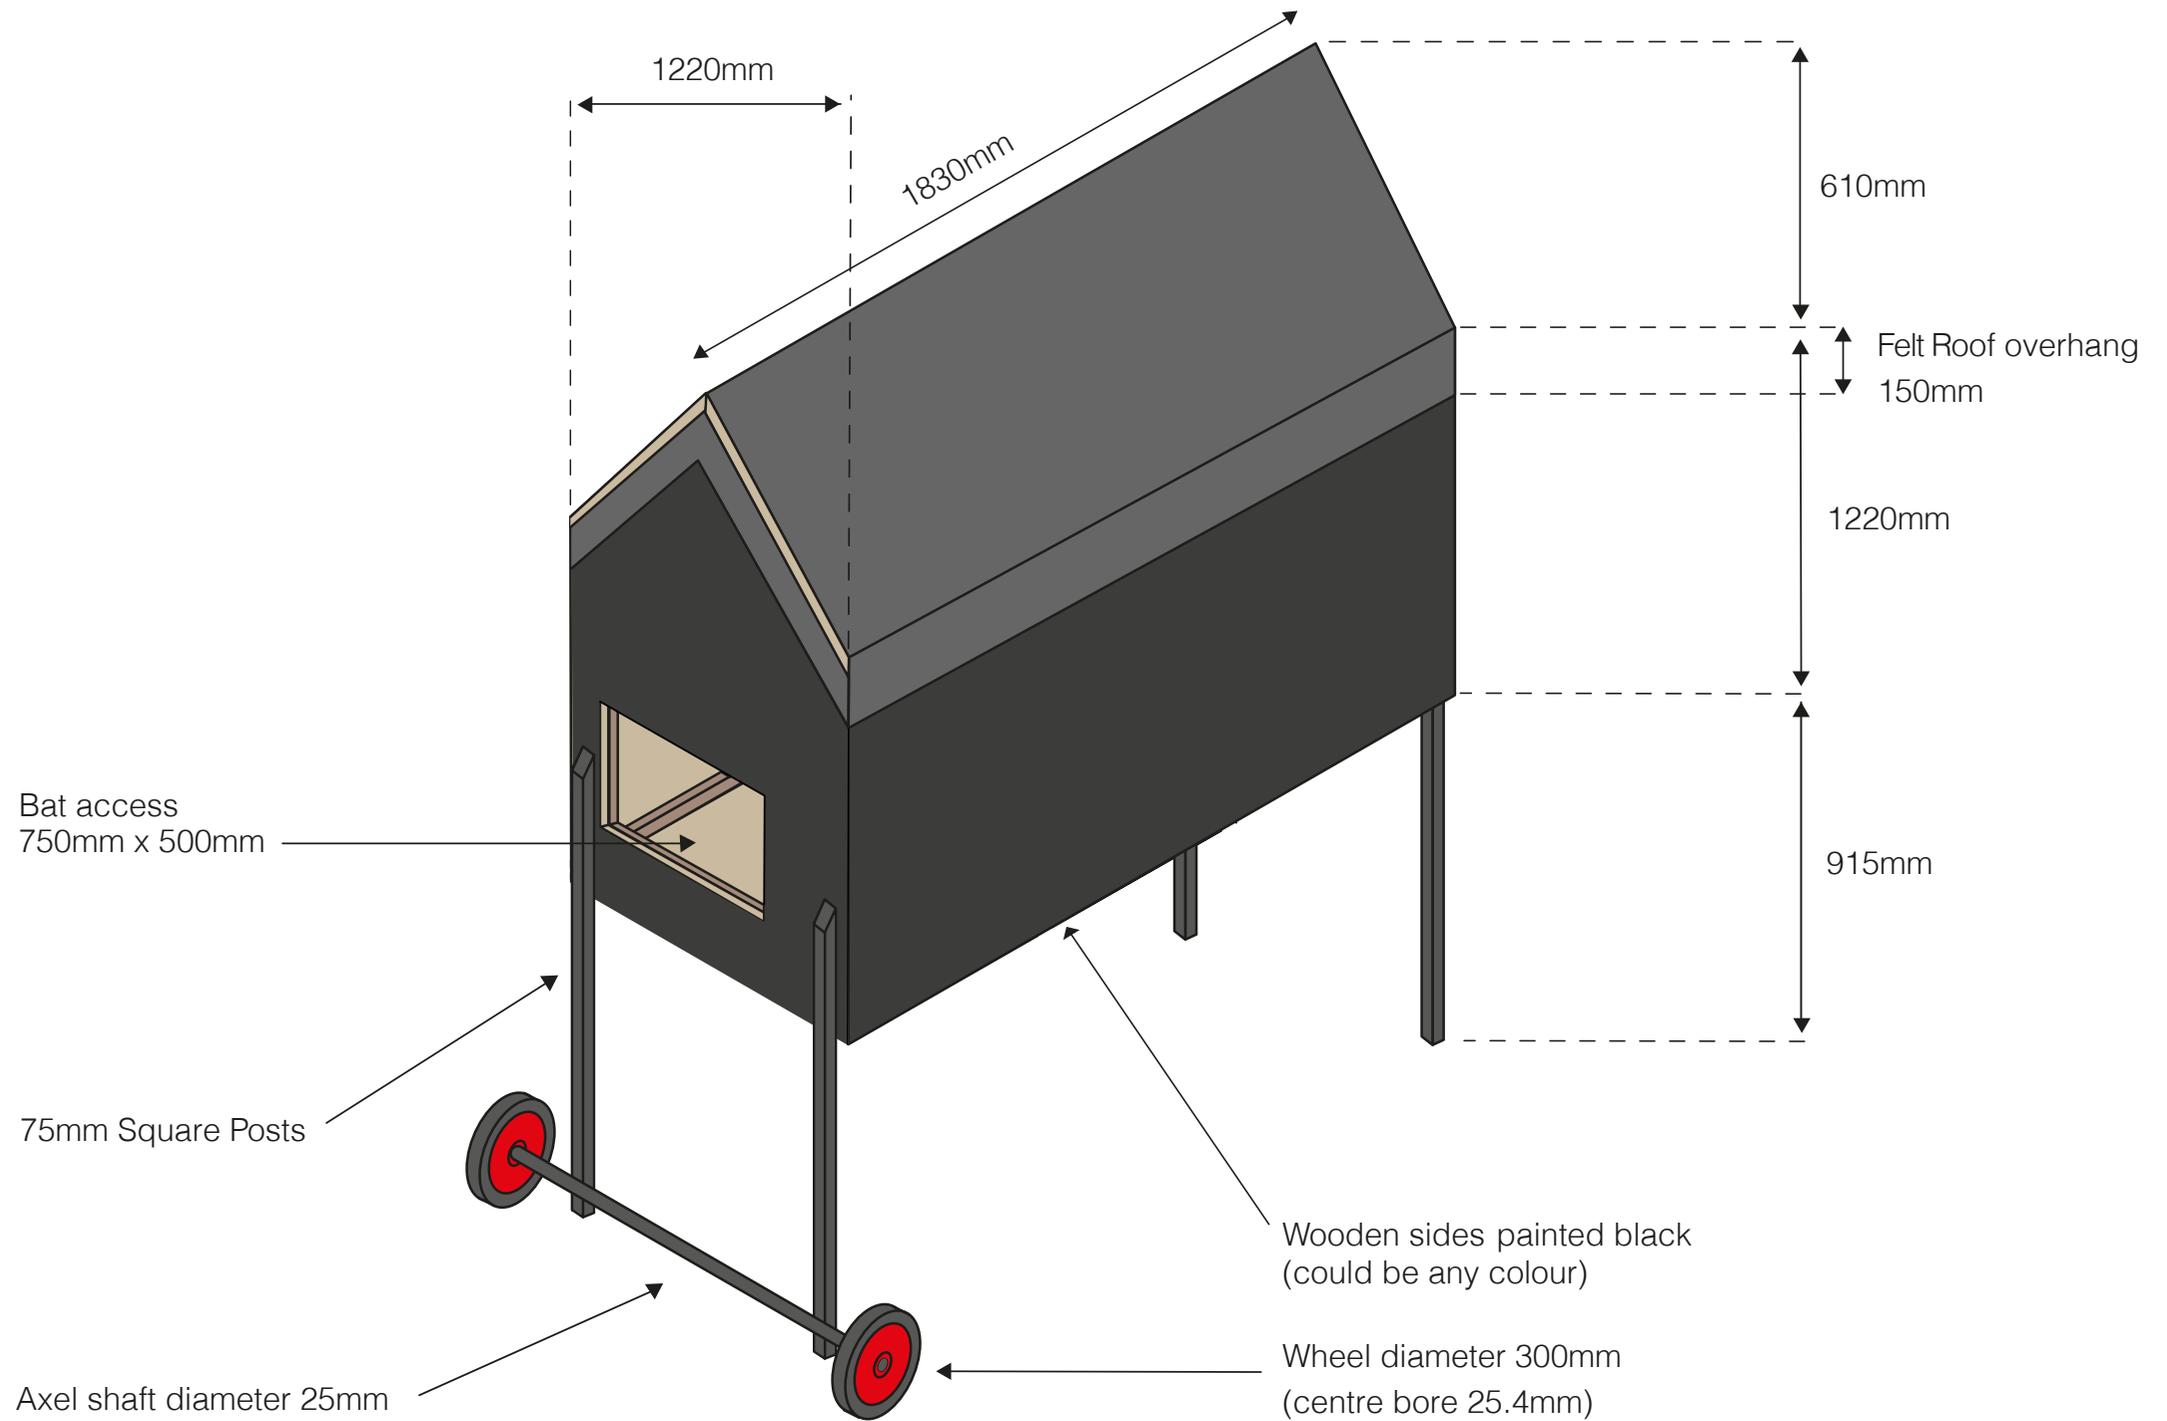
# Cathedine Night Roost Design

An alternative night roost design, which is also mobile, has been produced by the Vincent Wildlife Trust and is reproduced in Appendix C for comparative/guidance purposes. This is a smaller unit approximately 1.8m long, 2.2m wide and 1.8m high, raised approximately 1m off the ground, with a bat access flyway measuring 75cm wide by 50cm high.
